Flathead County Fairground Grandstand - 2024 Structural Condition Assessment

Report Date: June 21, 2024

Project No.: 24.0803.S.01

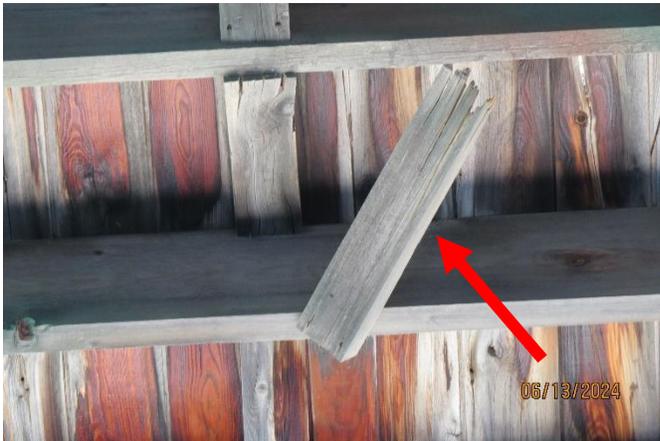
<p><u>Damage:</u> Loose or split bridging elements in grandstand canopy. These occur throughout the facility.</p> <p><u>Recommendation:</u> Remove and replace elements to prevent falling object hazard.</p>

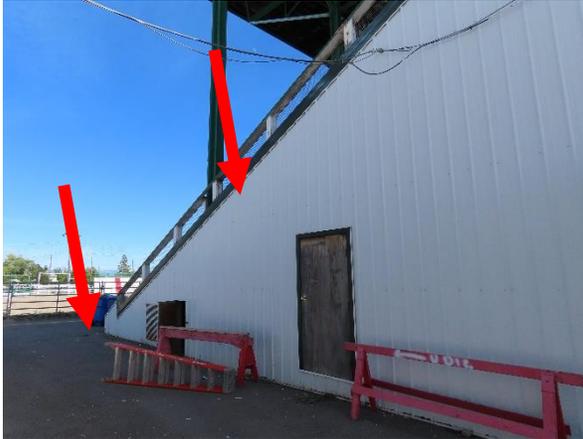
Damage: Leaning in the north end wall of the grandstand, in the northeast corner. This leaning was observed within the arrows shown in the photo to the left. At the northeast corner, the wall is leaning at approximately 7/8" per 1'-0". At the first canopy column (approximately 21 feet from the northeast corner), the wall is leaning at approximately 1/8" per 1'-0".

Recommendation: To mitigate further movement, we recommend attaching the wall to non-deteriorated members of the adjacent grandstand diaphragm, either through connecting the wall to non-deteriorated plank sheathing or connecting to the side of the first raker and bridging to adjacent rakers to distribute the load.

On a longer timeline, the client may rebuild the wall to bring it back to plumb for aesthetic reasons.

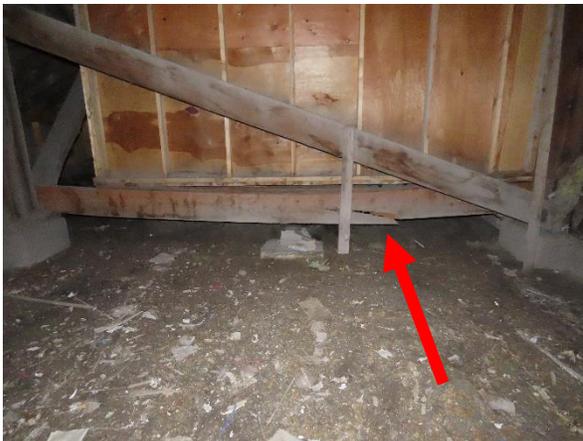
Damage: The second southernmost office storage room has failed structurally. The north girder has broken, the south girder has rotated, the joists are no longer in their seats, and the floor has dropped approximately 3 inches.

Recommendation: Do not use this storage room until it can be rebuilt and repaired. As this room is not attached to the grandstand above, this issue does not impact the operability of the grandstand.

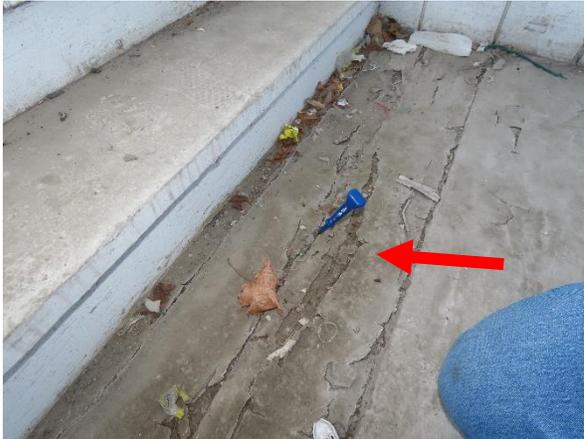
Damage: Deterioration in board sheathing at the base of both vomitorium stairs

Recommendation: We recommend that the vomitorium stairs remain closed to public use until repairs can be made, as noted in the high priority repair items below.

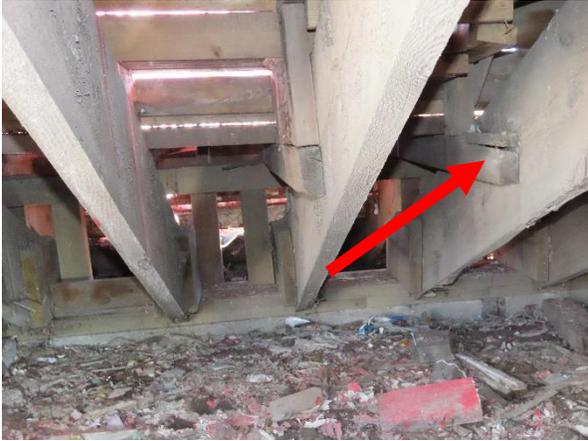
<p><u>Damage:</u> Splitting at fasteners in 2x4 elements supporting the treads and sheathing above.</p> <p><u>Recommendation:</u> Replace split boards.</p>

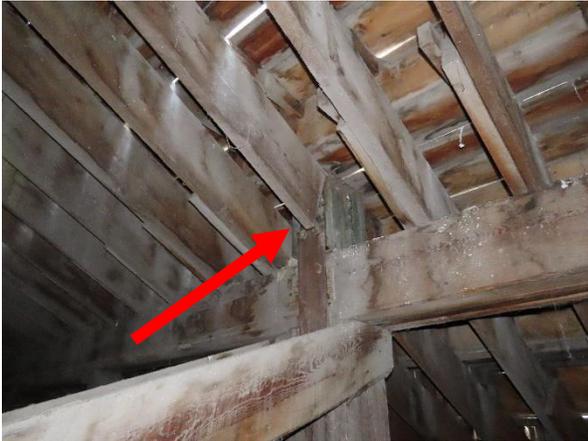
<p><u>Damage:</u> Multiple raker elements not supported at timber columns.</p> <p><u>Recommendation:</u> Install a support element to the multi-ply beam below to post up and support the end of the raker.</p>

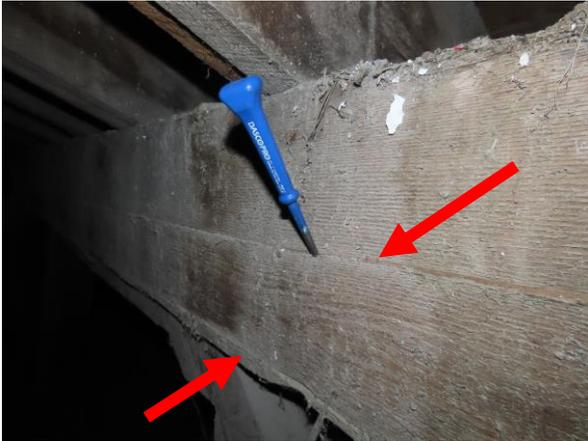
<p><u>Damage:</u> Delamination of the outer grains of a multi-ply beam along the easternmost line of columns and framing. Delamination was only observed in one ply of one beam.</p> <p><u>Recommendation:</u> Replace the outer ply of the beam with a matching element or sister a new ply of 2x12 lumber to the north side of the beam.</p>

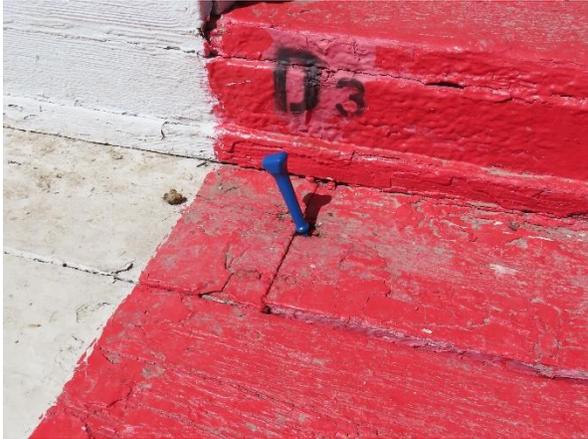
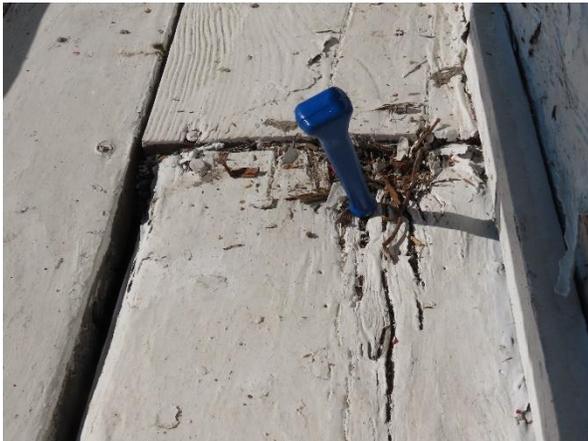
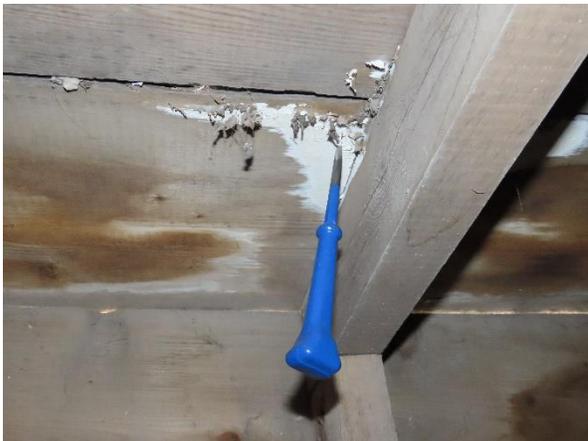
Damage: Deterioration in stair treads and board sheathing throughout grandstand. Deterioration was noted as being concentrated at the ends of boards, typically around the fasteners. Deterioration was concentrated around the south, east, and north ends of the structure, with select locations of additional deterioration throughout the structure.

For scale, photos show boards pierced with a 3" awl shank. The awl could be easily inserted into the boards up to ½ inch in many locations and all 3 inches in select locations.

Recommendation: Replace deteriorated boards in full. When boards are removed, inspect the rakers below for additional deterioration. If large regions of boards are removed, the owner may add flashing elements to the top of the rakers below to mitigate deterioration of those elements in the future.

At locations where deterioration is not observed, but fungus is present on the underside of the board, apply fungicides to mitigate further deterioration.

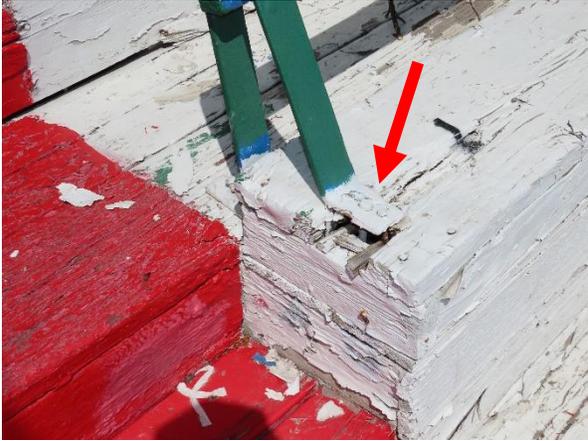
<p><u>Damage:</u> Backrest supports missing fasteners or fastened into deteriorated elements.</p> <p><u>Recommendation:</u> Replace missing fasteners and/or replace deteriorated boards in full.</p>

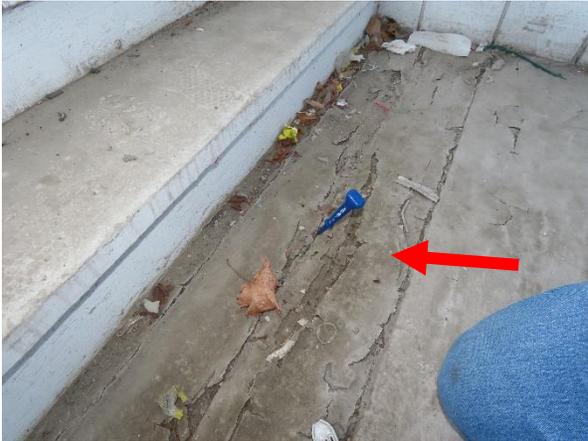
<p><u>Damage:</u> Deterioration in board sheathing at the base of both vomitorium stairs</p> <p><u>Recommendation:</u> Replace deteriorated boards in full. When boards are removed, inspect the rakers below for additional deterioration, as these members could not be observed from below and may also be deteriorated.</p> <p>After boards are replaced, install a drain system to direct water down to grade to mitigate future ponding at these locations.</p>

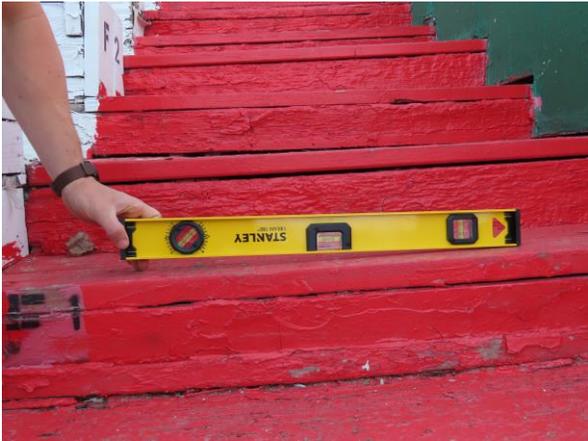
<p><u>Damage:</u> Excessive cross-slope on the northern stairs of the grandstand. Maximum slope observed was approximately 7/8" per 1'-0".</p> <p><u>Recommendation:</u> Remove stair treads and reinstall meeting IBC requirements. While boards are removed, inspect tread support elements for decay or deterioration before reinstalling.</p> <p>The ends of tread boards are to align with the rakers below or single 2x elements attached to the side of the raker. At locations where this is not achievable, install an element spanning between the rakers to support the end of the board.</p>

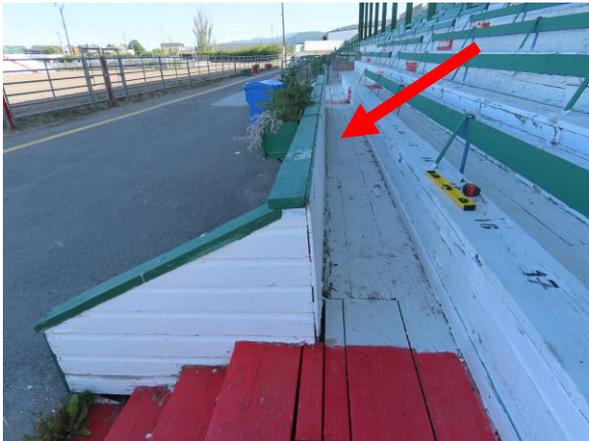
<p><u>Damage:</u> Leaning in the rail walls along the east edge of the grandstand. Maximum lean observed was approximately 3/4" per 1'-0".</p> <p><u>Recommendation:</u> Rebuild leaning walls.</p>

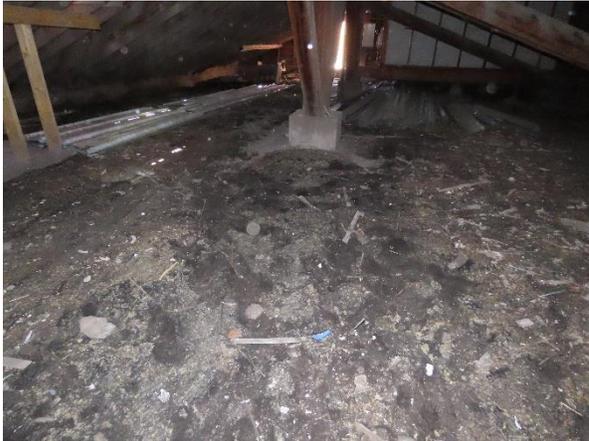
<p><u>Damage:</u> Spongy soil throughout the south half of the grandstand. On site staff stated that this is a known groundwater issue.</p> <p><u>Recommendation:</u> Install a vapor barrier throughout the underside of the grandstand to further limit moisture within the space. Vapor barriers are to be attached to concrete foundation elements around the perimeter of the space. Do not attach the vapor barrier to wood elements.</p>

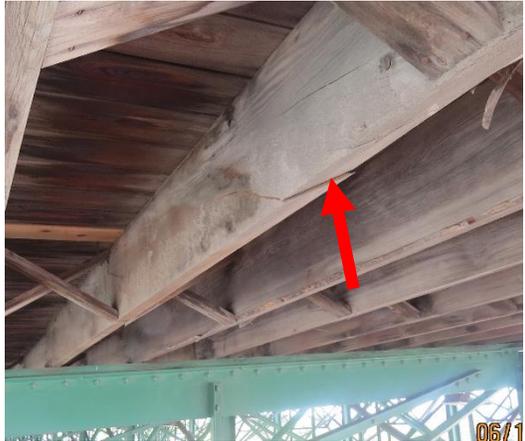
<p><u>Damage:</u> Localized cracks, checking, and delamination in wood purlins at canopy framing.</p> <p><u>Recommendation:</u> At locations where checking occurs at the bottom of the purlin and within the middle third of the purlin span, install a full-length sister purlin of equivalent size. Install new bridging elements to match the existing configuration.</p>

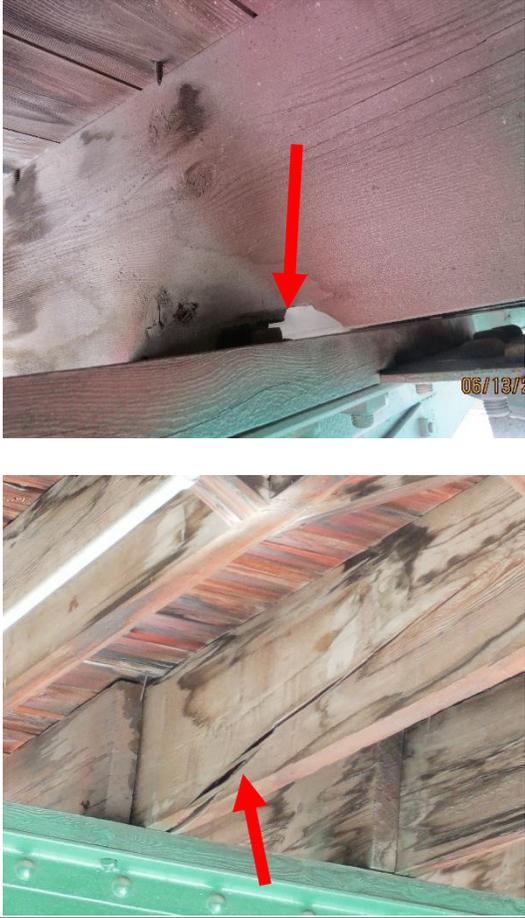
<p><u>Damage:</u> Localized notch and deterioration at purlin bearing.</p> <p><u>Recommendation:</u> Remove bridging and sister purlin with equivalent size wood member to reestablish bearing. Install new bridging elements to match the existing configuration.</p>

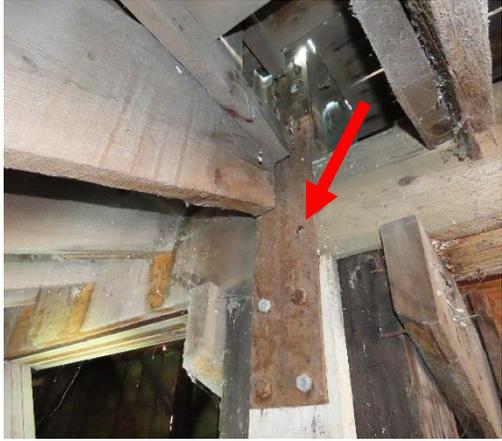
<p><u>Damage:</u> Missing fastener at built-up steel column to wood column transition.</p> <p><u>Recommendation:</u> Replace all loose/missing/deteriorated fasteners. Clean and paint exposed metal to prevent further deterioration. Regularly inspect and tighten bolts/fasteners.</p>

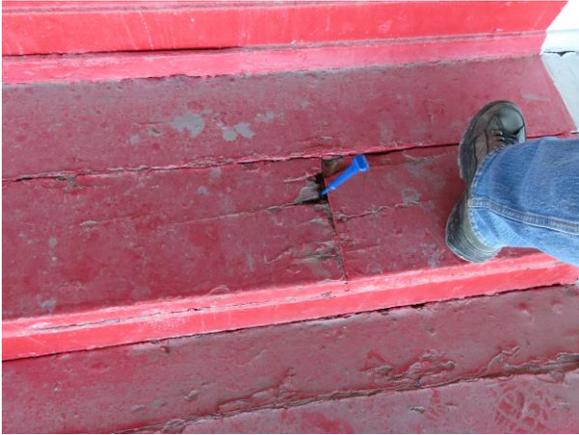
<p><u>Damage:</u> Peeling, chipping, and faded paint throughout grandstand. The paint helps to mitigate UV deterioration of the wood below, which can frequently create pathways for further water infiltration and deterioration.</p> <p><u>Recommend:</u> Sand down loose paint and repaint structure as paint deterioration occurs.</p>

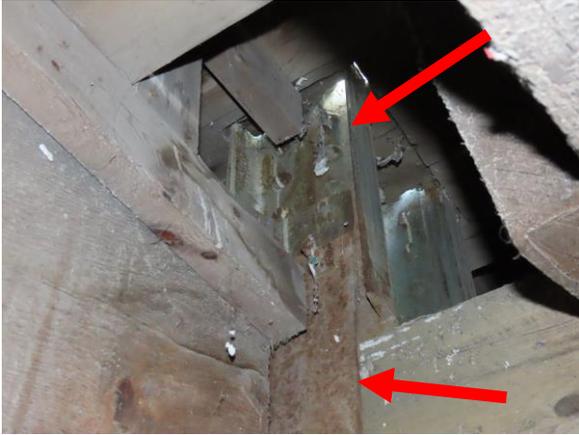
<p><u>Damage:</u> Minor corrosion at the base of steel columns and their connections to the timber post below.</p> <p><u>Recommend:</u> Clean all corrosion from steel elements and coat with rust-inhibitive coating.</p>

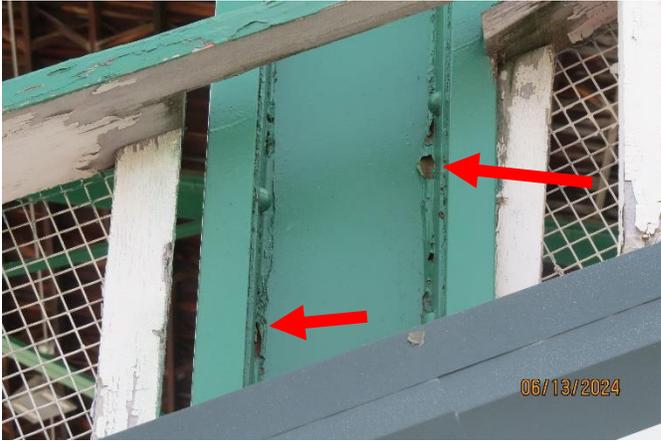
<p><u>Damage:</u> Localized peeling coating / corrosion staining on steel structural elements.</p> <p><u>Recommendation:</u> Clean corrosion and touch up paint with rust-inhibitive coating to protect the steel from corroding further.</p>

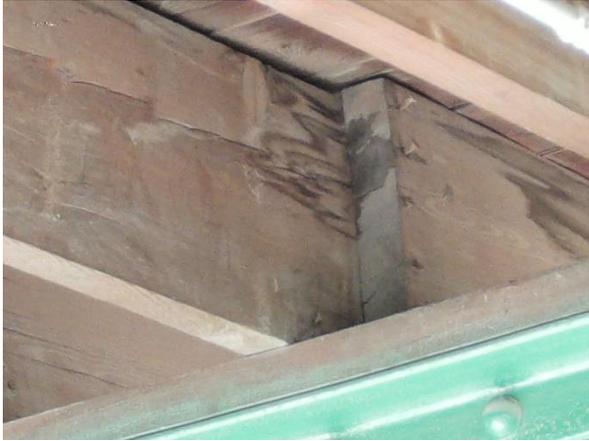
<p><u>Damage:</u> Localized loose / corroded nails at purlin-to-purlin connections at bearing over truss. Blocking is missing at purlin bearing locations.</p> <p><u>Recommendation:</u> Remove any corroded / loose nails and replace. Install blocking at purlin bearing locations.</p>

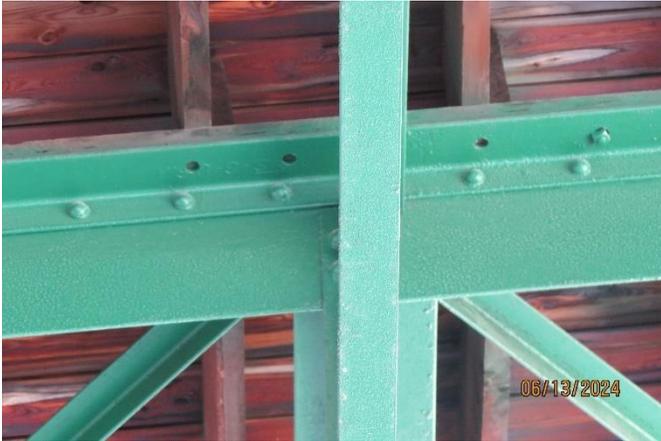
<p><u>Damage:</u> Localized missing bolts at truss top chord to sill plate connection.</p> <p><u>Recommendation:</u> Install bolts at missing connections between purlins. Install screws at missing connections below purlins.</p>

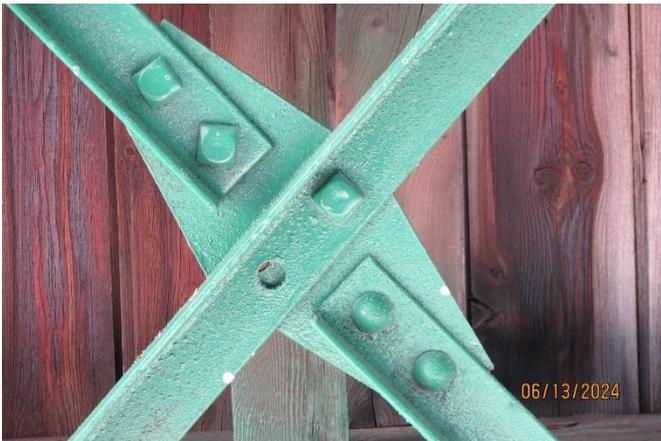
<p><u>Damage:</u> Localized missing bolts at truss lateral cross-bracing.</p> <p><u>Recommendation:</u> Drill out hole and install bolt with nut. Paint to match.</p>

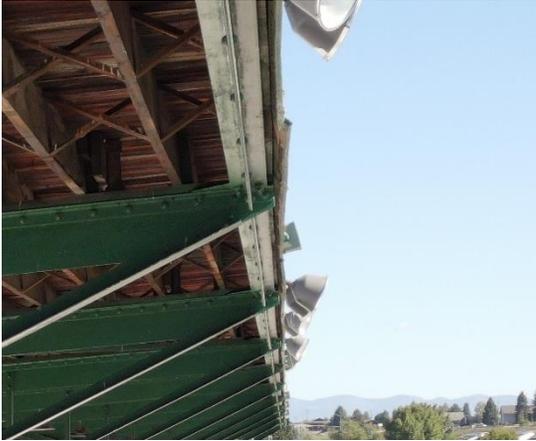
<p><u>Damage:</u> Localized loose / damaged rim boards at canopy perimeter.</p> <p><u>Recommendation:</u> Remove and replace loose / damaged rim boards.</p>

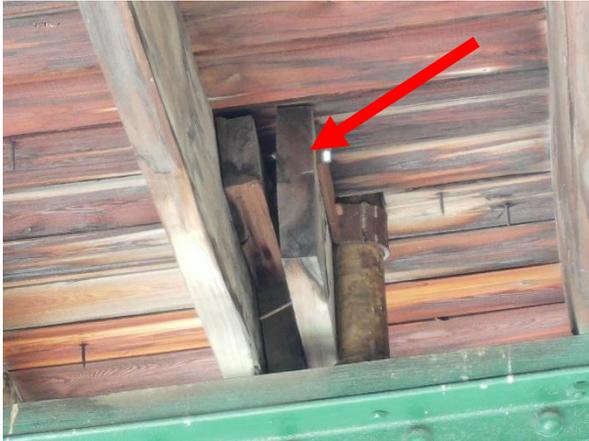
<p><u>Damage:</u> Global loose connections at flag pole base-to-purlin connections through roof. The fasteners are too short, and the blocking is cracked / damaged throughout.</p> <p><u>Recommendation:</u> Remove and replace all blocking and fasteners. Install new longer bolt to connect flag pole brace through purlin.</p>

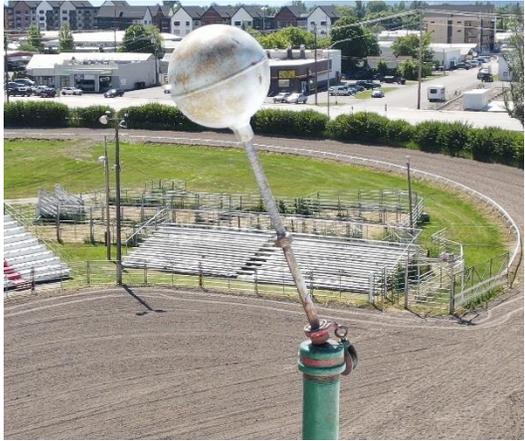
<p><u>Damage:</u> Localized loose / damaged orb atop flag poles.</p> <p><u>Recommendation:</u> Remove and replace connection of orb to top of flag pole.</p>

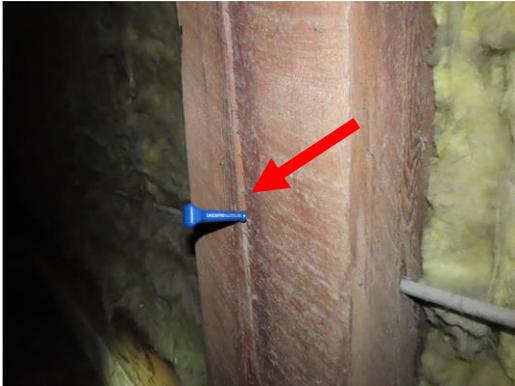
<p><u>Damage:</u> Localized checking down the center of multiple timber columns. Although the checking is up to 1/2 inch wide, we do not have any structural concerns about this condition.</p> <p><u>Recommendation:</u> Monitor checking to ensure cracks do not widen substantially or split through the column.</p>

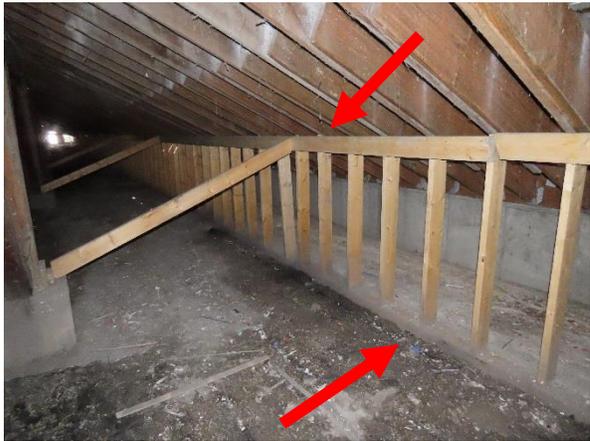
<p><u>Damage:</u> A temporary support wall had been installed for the cut rakers during the concrete ADA seating section construction. The wall was not removed and may create unforeseen load paths within the structure.</p> <p><u>Recommend:</u> Perform additional analysis to confirm that wall is temporary and remove the stud wall if it is not required.</p>

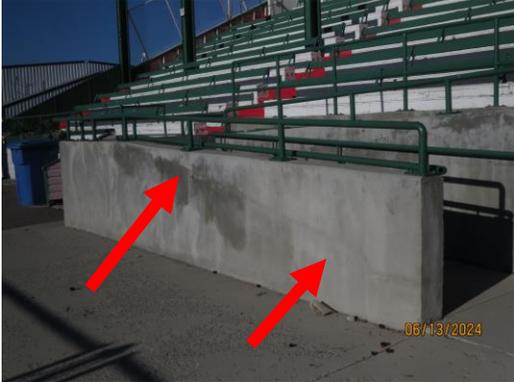
<p><u>Damage:</u> Hairline cracking in walls of ADA seating section and ramp.</p> <p><u>Recommend:</u> Monitor cracks and rout & seal cracks if they widen beyond 1/8 inch.</p>

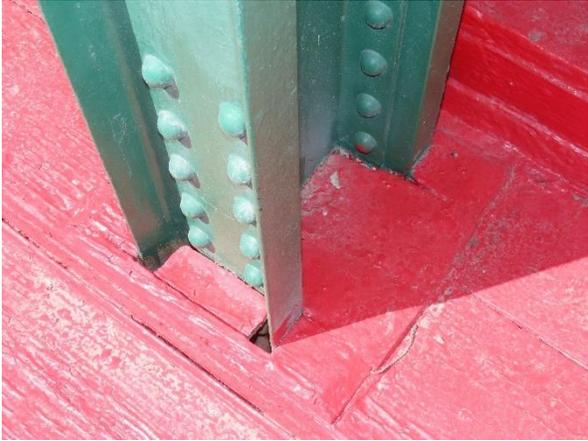
<p><u>Damage:</u> Localized openings in decking around canopy columns.</p> <p><u>Recommendation:</u> Seal openings in decking around columns to protect the connection below the grandstand from deteriorating further.</p>

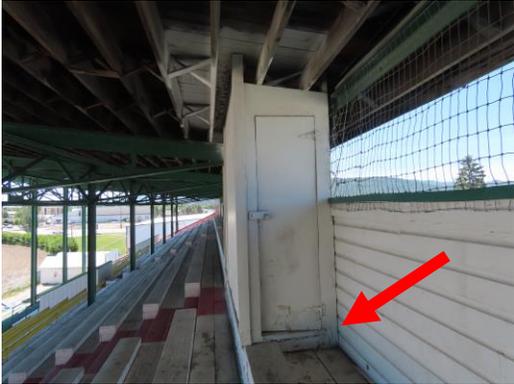
<p><u>Damage:</u> Minor wood deterioration was observed at the base of the room containing the roof access ladder. This room could not be accessed during our site visit.</p> <p><u>Recommend:</u> Investigate this room for any signs of wood deterioration and replace elements as needed. Verify that sound connections are present between the access ladder and its supporting structure.</p>

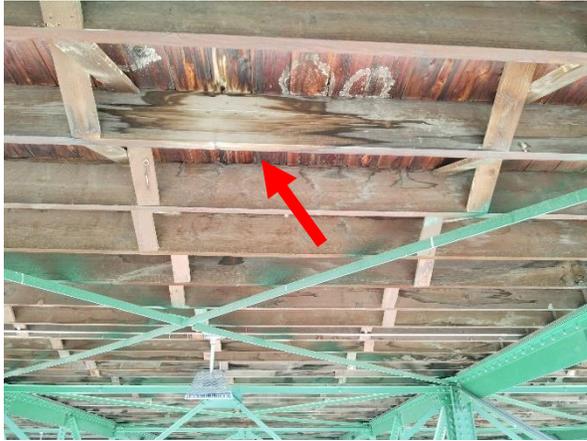
Damage: Global water staining on wood decking and purlins below roof.

Recommendation: Monitor underside of roof for active leaking and report findings to engineer. The staining is believed to be largely aesthetic and is not a structural concern. We also believe that painting or sealing the wood introduces risk of deteriorations. The paint can trap moisture and hide damages. This also involves a continuous maintenance task that will need to be redone every 3 – 5 years.

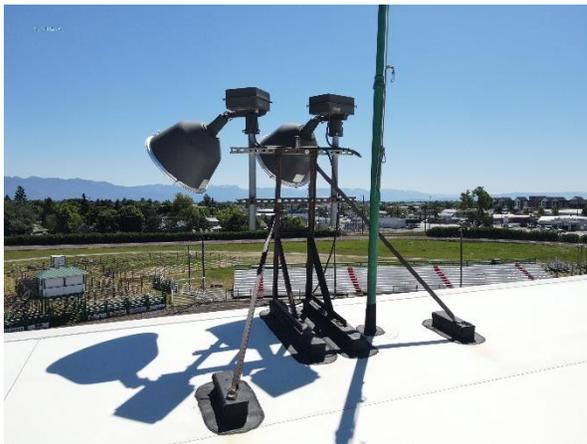
Damage: Minor corrosion at light supports.

Recommendation: Clean all corrosion from steel elements and coat with rust-inhibitive coating.

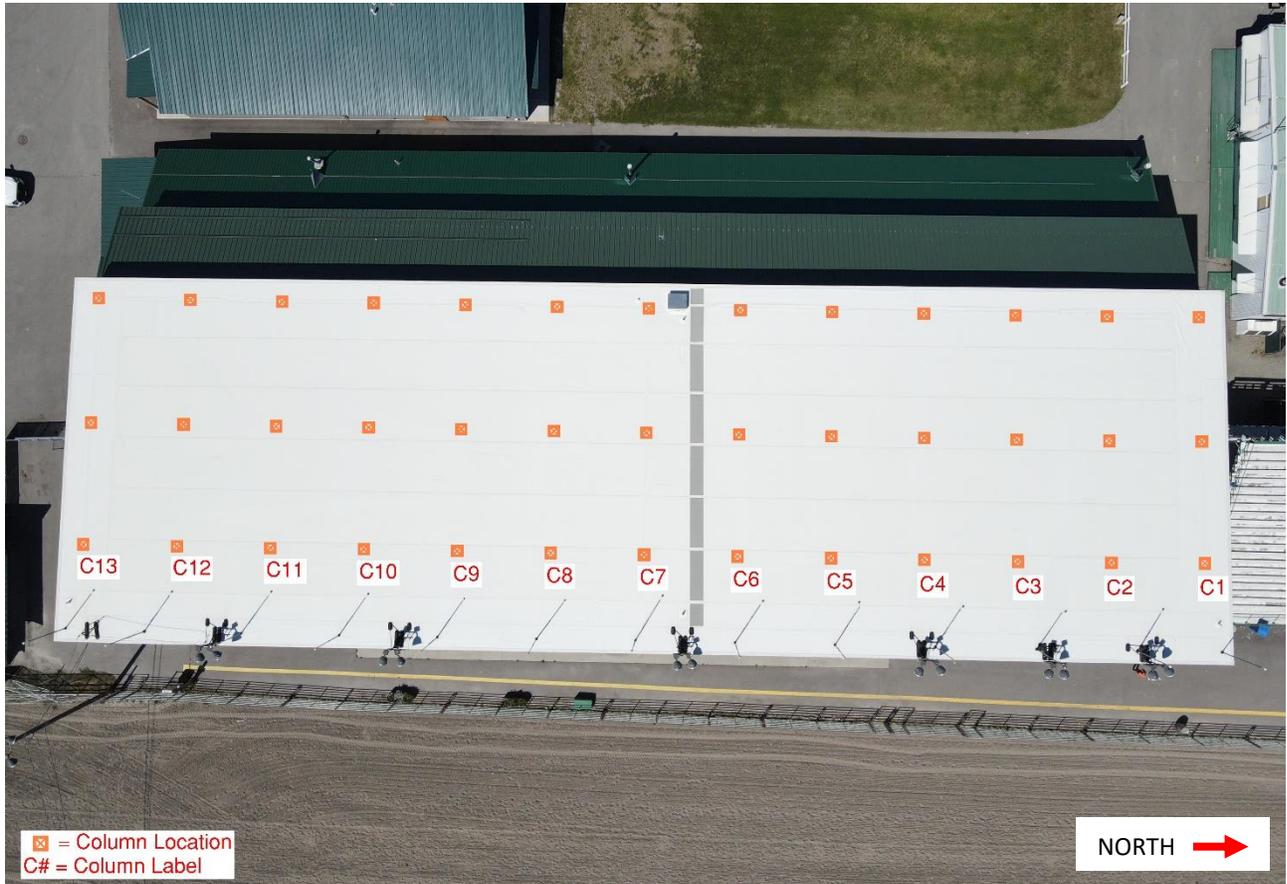
Figure 5: Grandstand column layout

- There does not appear to be a trend between each column indicating that the overall building is settling in any specific direction.
- No single column elevation is different enough from its adjacent columns to warrant further investigation beyond an additional elevation survey at a future date.

See Figure 5 and Table 2 below for a map of measured foundation elevations. Note that Column #1 is noted as 0.000 inches, not due to its relative elevation to the overall grandstand, but simply to set a baseline elevation for the other data provided in this map. Additionally, positive numbers denote that the column is higher than Column C1 and negative number denote that the column is lower than Column C1
