Flathead County Fairground Grandstand - 2024 Structural Condition Assessment

Report Date: June 21, 2024

Project No.: 24.0803.S.01

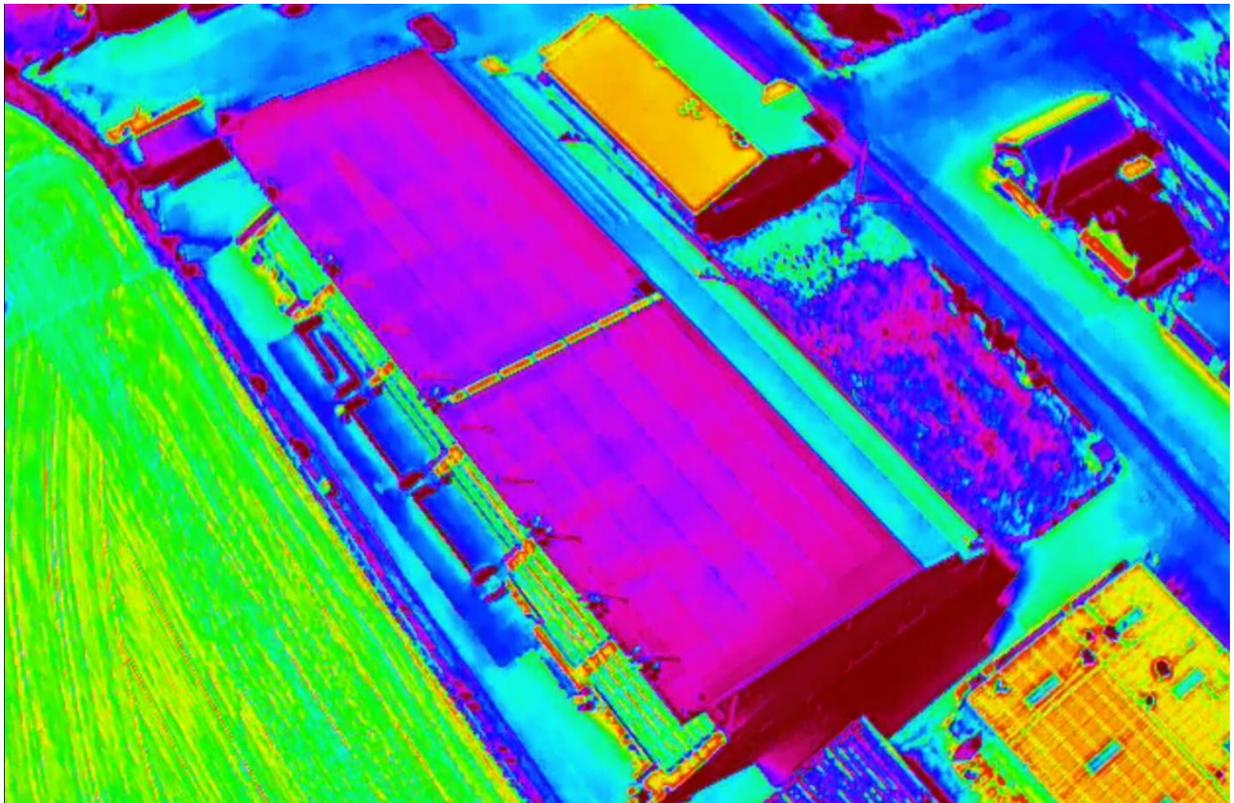
Figure 4: Aerial thermal image of grandstand structure

We used cameras with telescoping lenses and an aerial drone equipped with both thermal imaging and zoom cameras to visually document conditions at the structure. The drone was used to observe the underside and topside of the canopy framing of the structure. The drone’s thermography camera captures infrared (IR) images that can be analyzed to investigate temperature differentials across a surface, which can show if moisture has infiltrated the assembly and deteriorated the framing. Thermal images were taken of the roof of the canopy structure (See Figure 4), and no substantial deterioration or leak locations were observed (in the form of thermal irregularities).

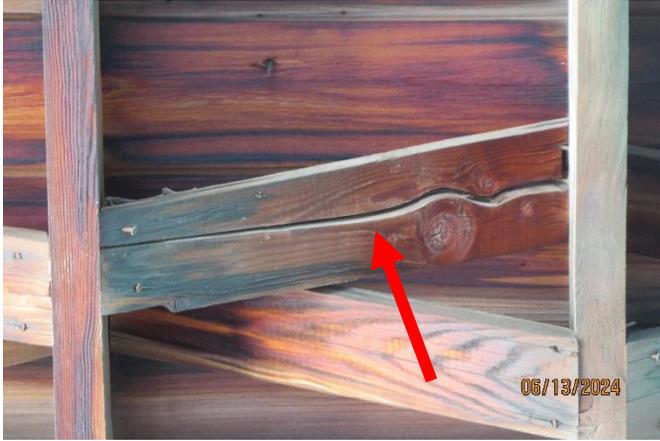
<p><u>Damage:</u> Loose or split bridging elements in grandstand canopy. These occur throughout the facility.</p> <p><u>Recommendation:</u> Remove and replace elements to prevent falling object hazard.</p>
